PERFORMANCE OF POLYVINYL CHLORIDE (PVC) ROOFING:
RESULTS OF A TEN-YEAR FIELD STUDY

Paper Presented at the
Fourth International Symposium on Roofing Technology

17-19 September 1997
Gaithersburg, Maryland, USA

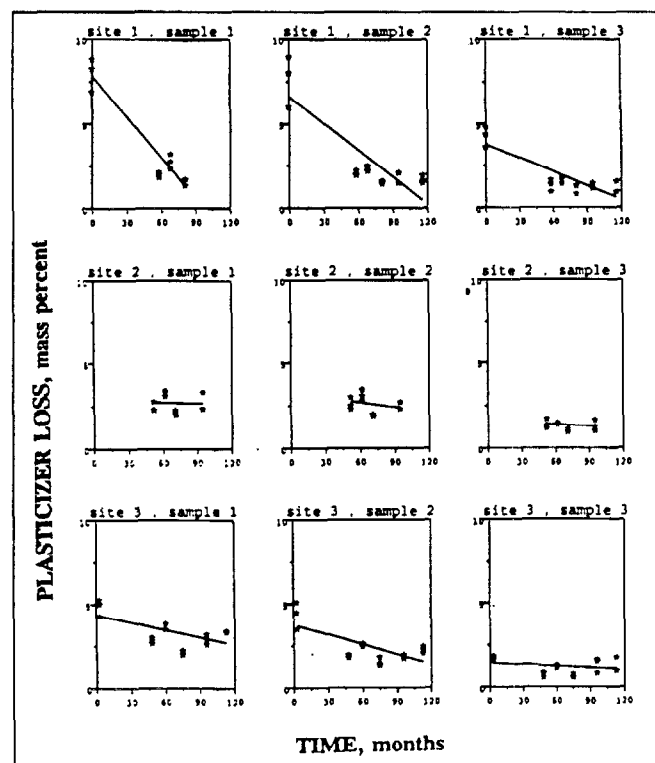
Figure 4. Results of the plasticizer loss tests.

The following comments may be made about the plasticizer loss results given in Table 4 and Figure 4:

2 samples were 52 months old. For the available data at Site 2, none of the slopes of the regression lines were statistically different from zero. This may be an indication that the plasticizer available for loss during the test may have reached a constant value when the series of tests of Site 2 samples began. Note, in a similar observation, that the samples at Sites 1 and 3 showed little variation in the plasticizer loss values measured after 48 months.

- For each sample, the values of plasticizer loss were greater (by a factor of about 2) at Site 1 than at Site 3. Reasons for this observation (e.g., material variability, test method variability, or unknown factors related to shipping, installation or initial outdoor exposure) are not known.
- For Samples 1 and 2, the final values of plasticizer loss were lower at Site 1 (ballasted membranes) than at Site 3 (exposed membranes). For Sample 3, the final values were about the same at Site 1 and at Site 3.
- A comparison of the estimated percent change over 100 months for the samples at Sites 1 and 3 has little meaning considering the greater initial values at Site 1 versus Site 3. It is noted that, for the samples, four of the six regression lines had slopes statistically different from zero.

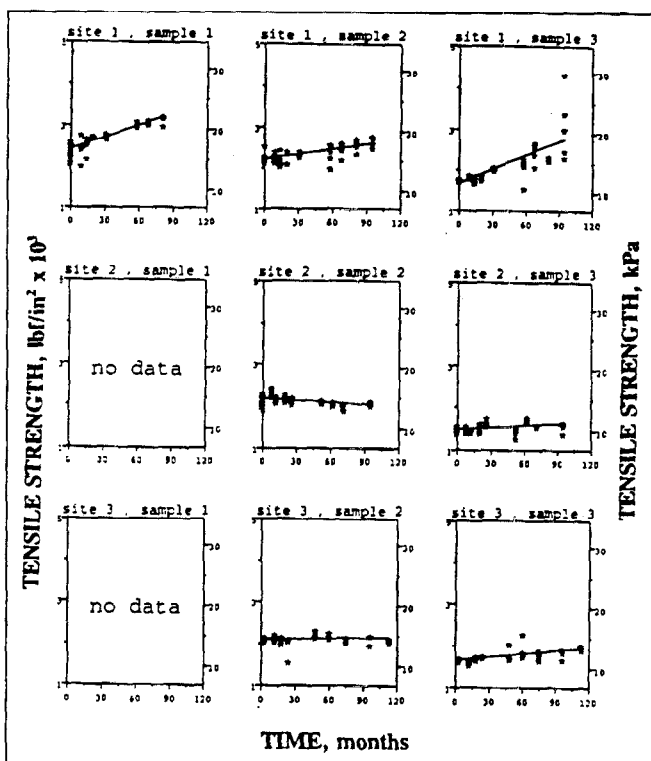
Figure 5. Results of the tensile strength tests.

The following comments may be made about the tensile strength results given in Table 5 and Figure 5:

- Initial tensile strength for Sample 1 was stronger than Sample 2, which was stronger than Sample 3.
- With the exception of Sample 2 at Site 2, the slopes of the regression lines were positive, indicating an increase of strength with time. With the exception of Sample 2 at Site 3 and Sample 3 at Site 2, the slopes were statistically different from zero.
- Sample 3 at Site 1 showed the largest estimated percent increase over time (68 percent). The data for this sample had considerable scatter at the longer exposure times, which may have contributed to the estimated increase.

- For the data set, the three samples at Site 1 showed the largest estimated percent increase. Site 1 membranes were ballasted and experienced problems in service.
- The largest estimated percent change for a nonballasted system was found for Sample 3 at Site 3. This value (16 percent) was comparable to that (18 percent) found for the ballasted Sample 2 at Site 1.

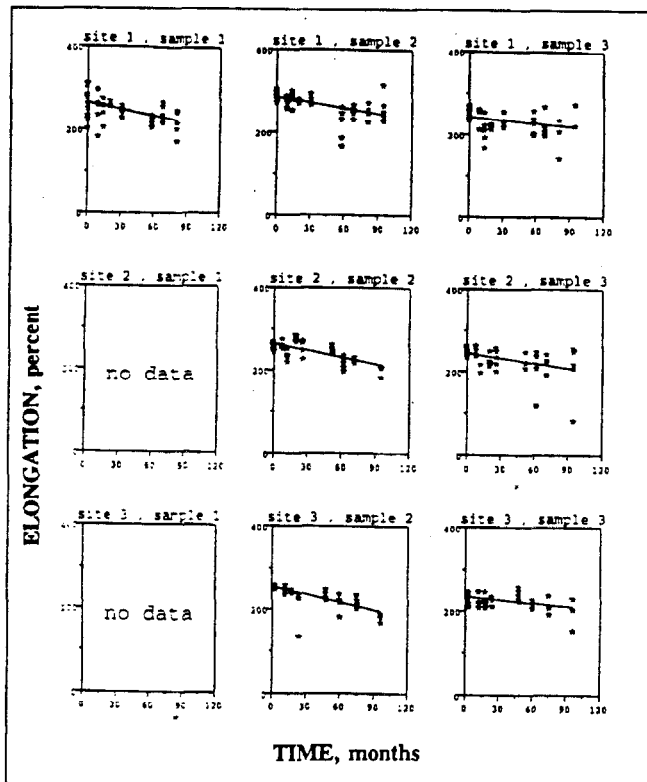
Figure 6. Results of the elongation tests.

The following comments may be made about the elongation results given in Table 6 and Figure 6:

- For all samples, the initial elongations were comparable, ranging from about 230 to 290 percent.
- All samples showed a decrease in elongation over time. The slopes of the regression lines were statistically different from zero in six of the seven cases. The exception was Sample 3 at Site 2, which was nearly significant. (The estimated value of the slope was 2.6 times its standard deviation.)

- The ballasted Sample 3 at Site 1 had an estimated decrease that was greater than those of the exposed Sample 3 at Sites 2 and 3.
- The ballasted Sample 2 at Site 1 had an estimated decrease that was less than those found for the nonballasted Sample 2 at Sites 2 and 3.

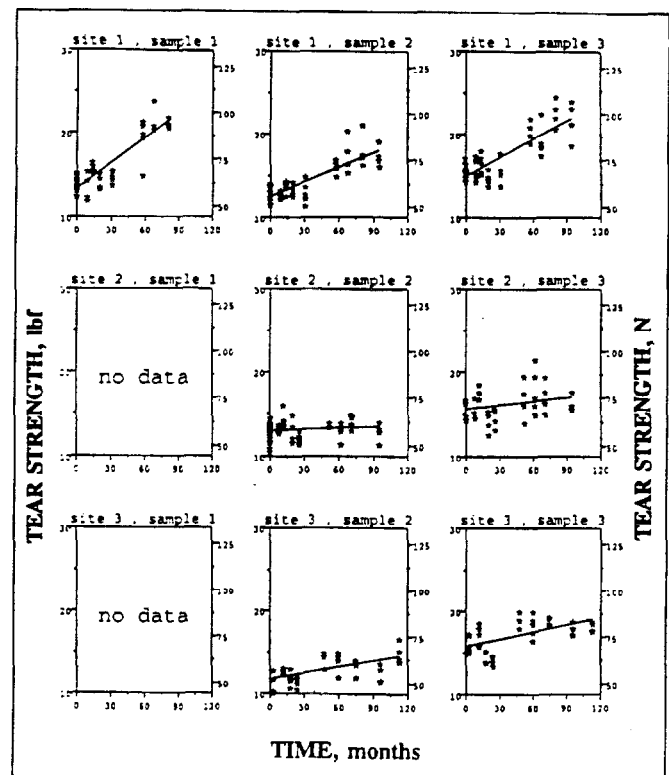
Figure 7. Results of the tear strength tests.

The following comments may be made about the tear strength results given in Table 7 and Figure 7:

- Sample 3 had the greatest initial tear strength; Sample 2 had the lowest value.
- All samples showed an increase in tear strength over time. With the exceptions of Samples 2 and 3 at Site 2, the slopes of the regression lines were statistically different from zero:
- The ballasted roofs at Site 1 showed the greatest estimated increase; the values were more than twice the estimated change for any of the nonballasted roofs at Sites 2 and 3.

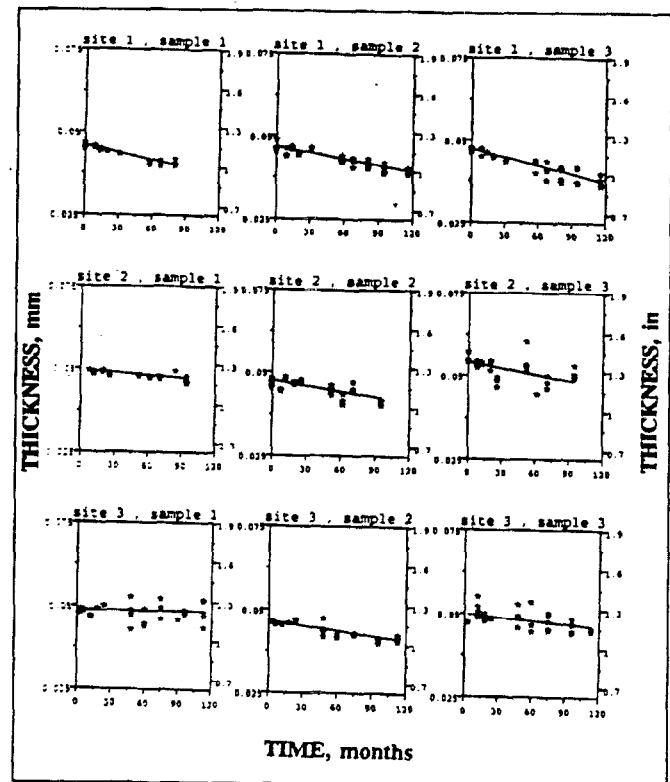
Figure 8. Results of the thickness tests.

The following comments may be made about the thickness results given in Table 8 and Figure 8:

- With the exception of Sample 1 at Site 3, the thickness of the samples at all sites decreased over time, ranging from 5 to 18 percent. In these cases, the negative slope of the regression line was statistically different from zero. It is not known whether the reduction in thickness was associated with factors such as relaxation shrinkage, loss of plasticizer, erosion of the surface, or, in the case of ballasted membranes, creep associated with the load of the ballast.
- The ballasted samples at Site 1 experienced the greatest estimated decrease in thickness.

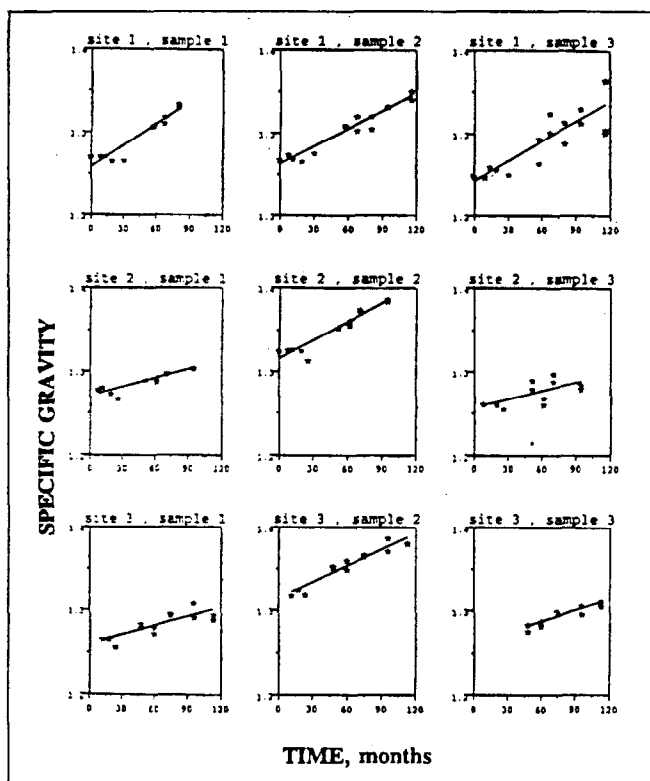
Figure 9. Results of the specific gravity tests.

The following comments may be made about the specific gravity results given in Table 9 and Figure 9:

- The initial specific gravities of all samples were comparable, ranging from 1.25 to 1.33.

- All samples at all sites exhibited an increase in specific gravity over time. With the exception of Sample 3 at Site 2, the slopes of the regression lines were statistically different from zero.
- The estimated percent changes for the ballasted Samples 1 and 3 at Site 1 were about twice that for these two unballasted samples at Sites 2 and 3.
- In the case of Sample 2, the estimated percent change for the ballasted material at Site 1 was essentially the same as that for the unballasted materials at Sites 2 and 3.

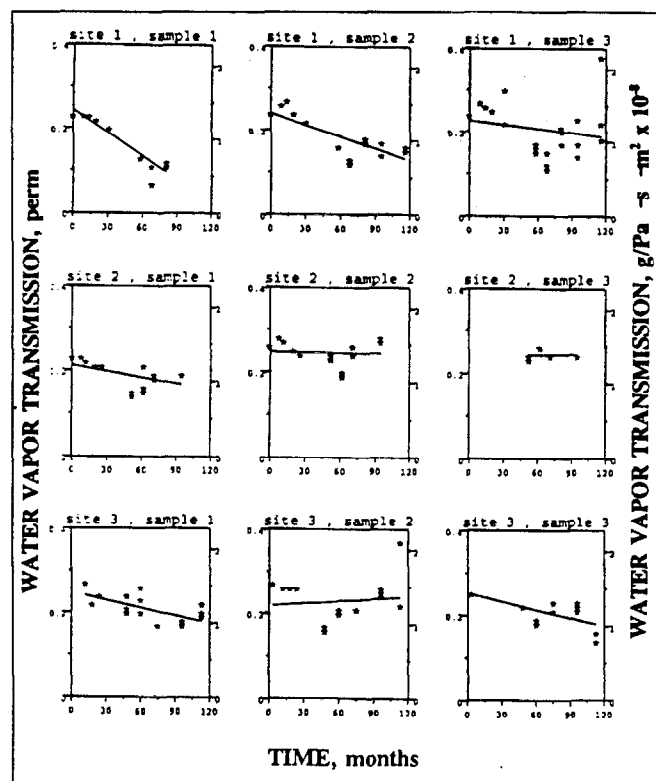
Figure 10. Results of the water vapor transmission tests.

The following comments may be made about the water vapor transmission (WVT) results given in Table 10 and Figure 10:

- Most samples displayed decreases in WVT over time. However, only three (Sample 1 at Sites 1 and 3 and Sample 2 at Site 1) had regression lines with slopes statistically different from zero.
- In most cases where the slope was not statistically different from zero, considerable scatter in the data occurred.
- For Samples 1 and 2, the rate of decrease in WVT was considerably greater at Site 1 (ballasted installation) than at the other two sites.
- For Sample 3, the ordering is unclear due to the large uncertainties in the estimated changes at Sites 1 and 3.

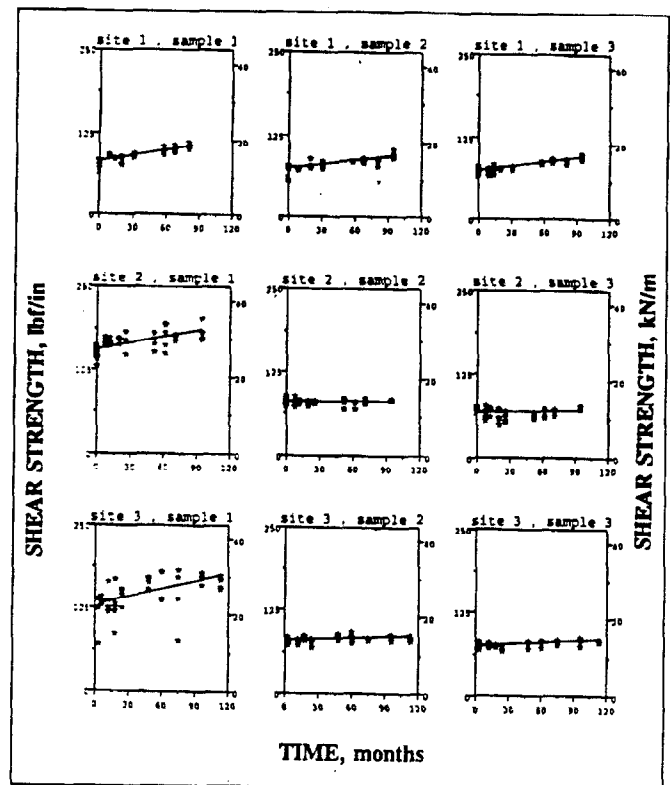
Figure 11. Results of the seam shear strength tests.

The following comments may be made about the seam shear strength results given in Table 11 and Figure 11:

- The estimated percent increases in seam shear strength for the ballasted membranes at Site 1 were found at the high end of the range, with values from 26 to 35 percent.
- Samples 2 and 3 at Site 2 experienced no statistically significant change in seam shear strength with time.

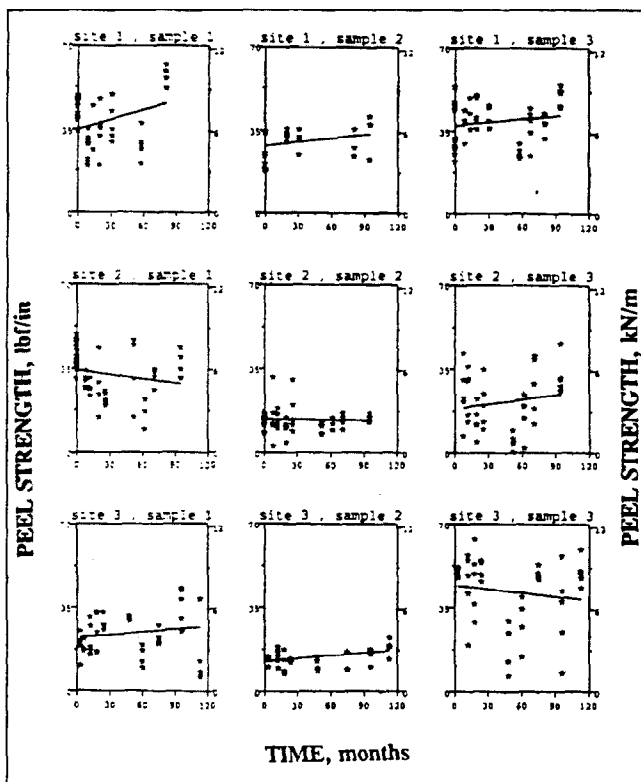
Figure 12. Results of the seam peel strength tests.

The following comments may be made about the seam peel strength results given in Table 12 and Figure 12:

- None of the changes in seam peel strength had regression lines with slopes statistically different from zero. Considerable scatter was evident in the data in all cases. The scatter may be associated with the difficulties encountered in performing the peel tests.
- Important differences between the peel strengths of seams of the various samples may have been expected only if the bonding processes during membrane installation had been inadequate. This was unlikely in this study as all seams performed satisfactorily over the service lives of the membrane samples.
